Photographic Log for Memphis Regional Intermodal Facility

Operator:		Site Location:	Tracking No.:
Norfolk Southern Railway Company		Rossville, Fayette County	TN0081108
Photo No.	Date		
1	8-30-12		
Description <ul style="list-style-type: none"> • Phase 1A EC-11 • The swale located south of the eastern wye track and main line track up-gradient from SW23 is shown in this photo. • The bottom of the swale appeared to be sufficiently stabilized/vegetated. However, the slopes of the berm were not - see photo 2 for close-up of berm. • Although the berm appears to have more established vegetation than during the March 12, 2012, inspection, the berm remains insufficiently stabilized/vegetated.

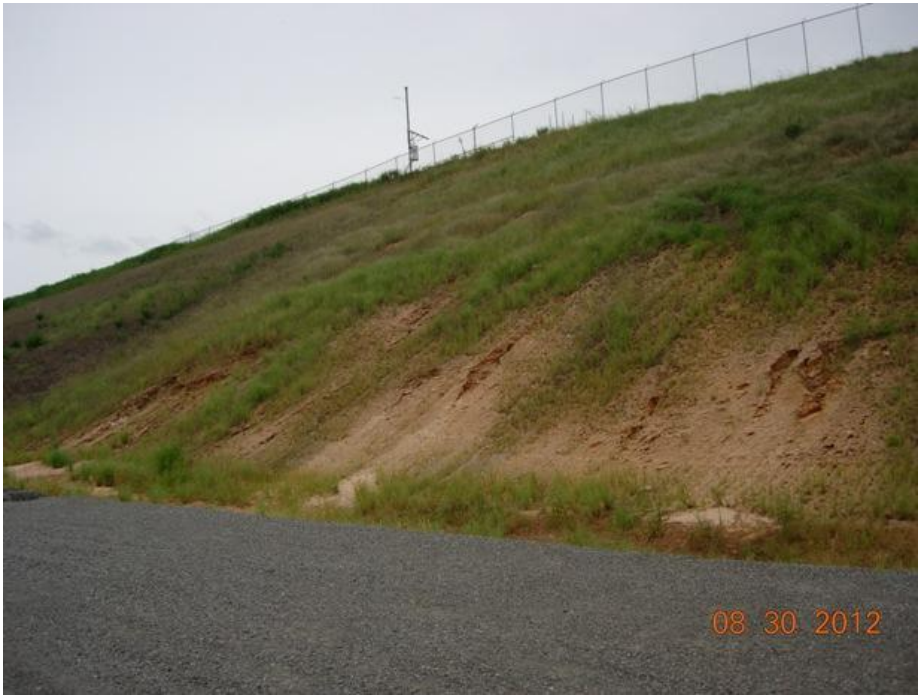
98	8-30-12		
Description <ul style="list-style-type: none"> • Phase 2 EC-27 • This photo is another example of the insufficient vegetation/stabilization on the northern draining eastern drainage ditch. • Although the area appeared to have more established vegetation than during the August 23, 2011, and March 12, 2012, inspection, the vegetative cover remains insufficient. • Drainage from this area flows into Sediment Basin 8, which was discharging at the time of the inspection. • Rills and gullies were observed. • Rills and gullies were also observed during the August 23, 2011, and March 12, 2012, inspections.

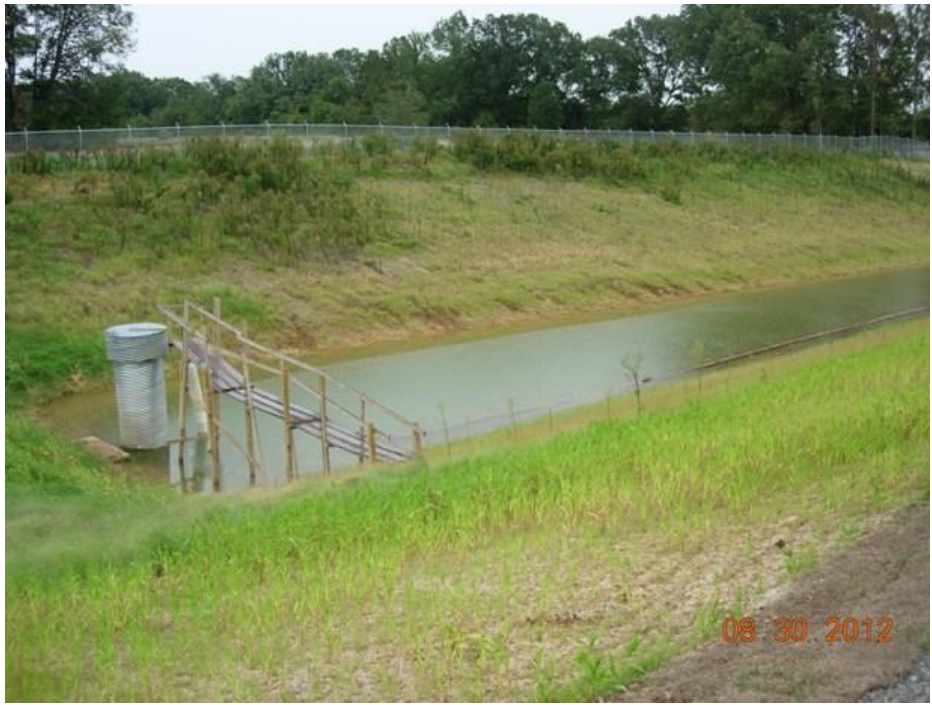
Operator:		Site Location:	Tracking No.:
Norfolk Southern Railway Company		Rossville, Fayette County	TN0081108
Photo No.	Date		
101	8-30-12		
Description <ul style="list-style-type: none"> • Phase 2 EC-25 • Sediment Basin 8 • Water was discharging from Sediment Basin 8 at the time of the inspection. It did not appear to be a controlled release via the riser pipe, but rather a leak. Ms. Hagerty indicated that she would have someone look into it. • Portions of the slopes within the basin were not sufficiently vegetated. • Rills were observed.
